Section 19

Flood and Water Management
Act 2010

Ref S19-870

Date and version number –
09/12/2024

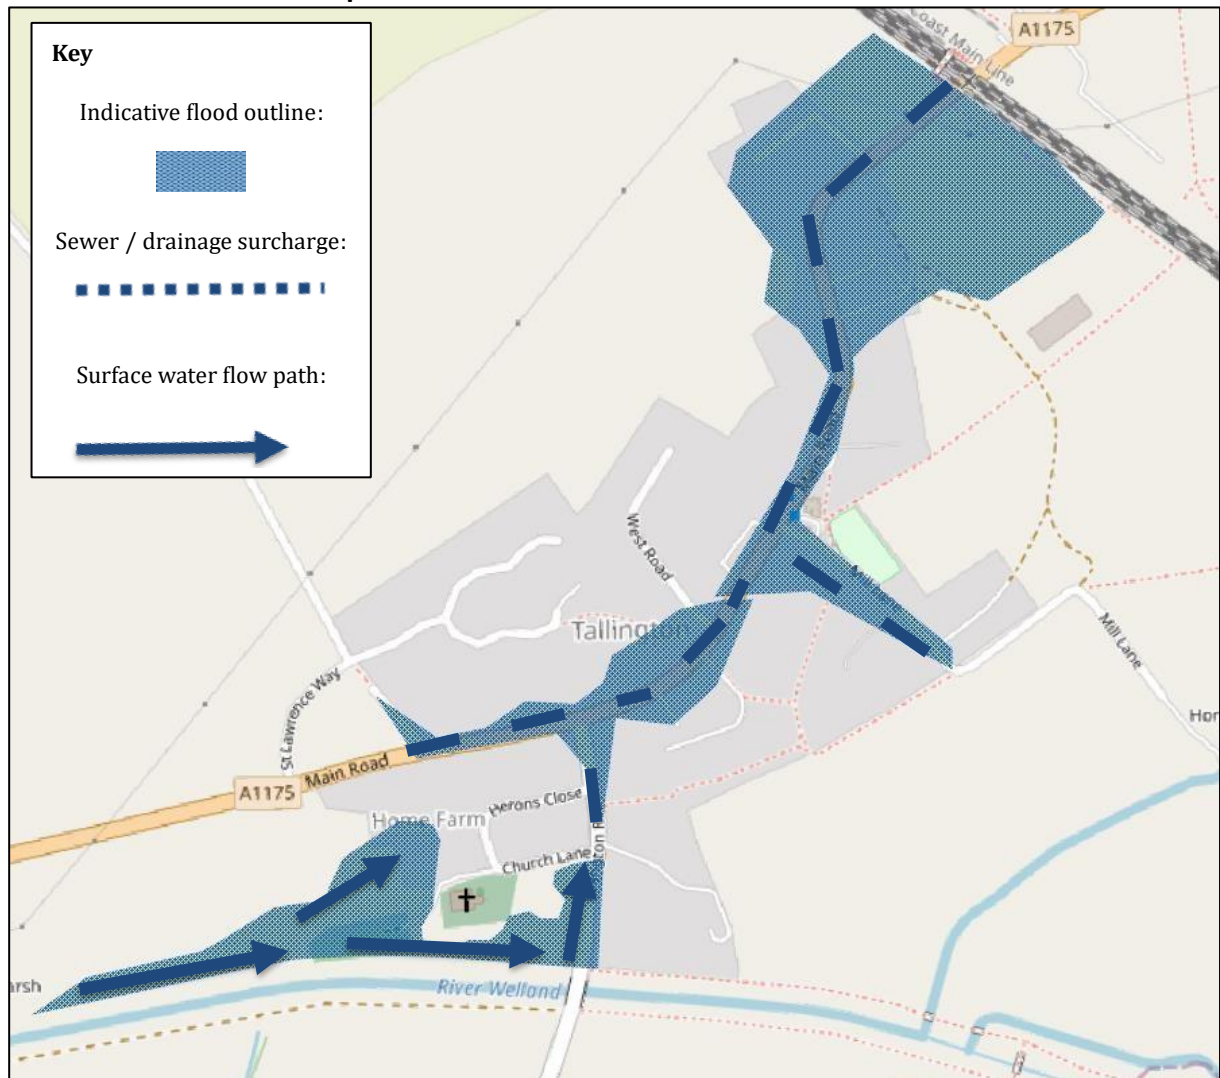
(Figure 7 Indicative flood event outline as reported by residents)

Information provided by residents to the Parish Council suggests that a total of 24 properties were internally flooded throughout the village on Tallington Road, Church Lane, Main Road, Mill Lane and Searson Close. Most properties impacted were located directly adjacent to a highway / surface water sewer.

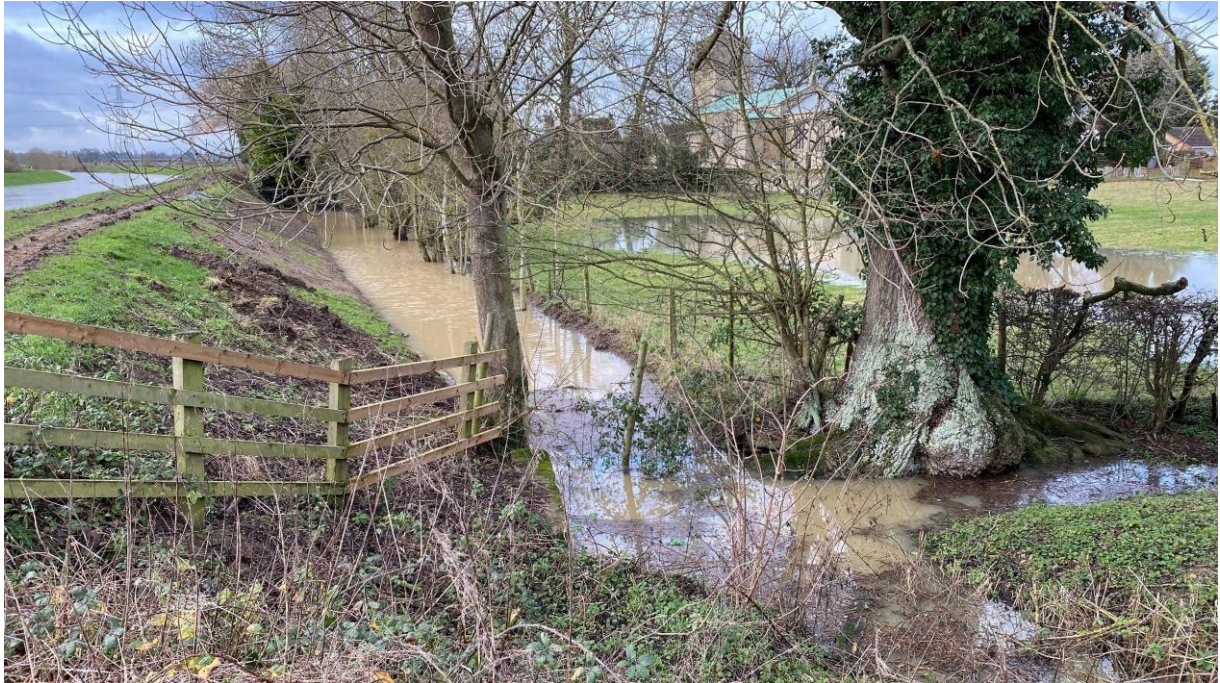
(Photo 2 - 03/01/2024 Just north of the River Bridge looking west)

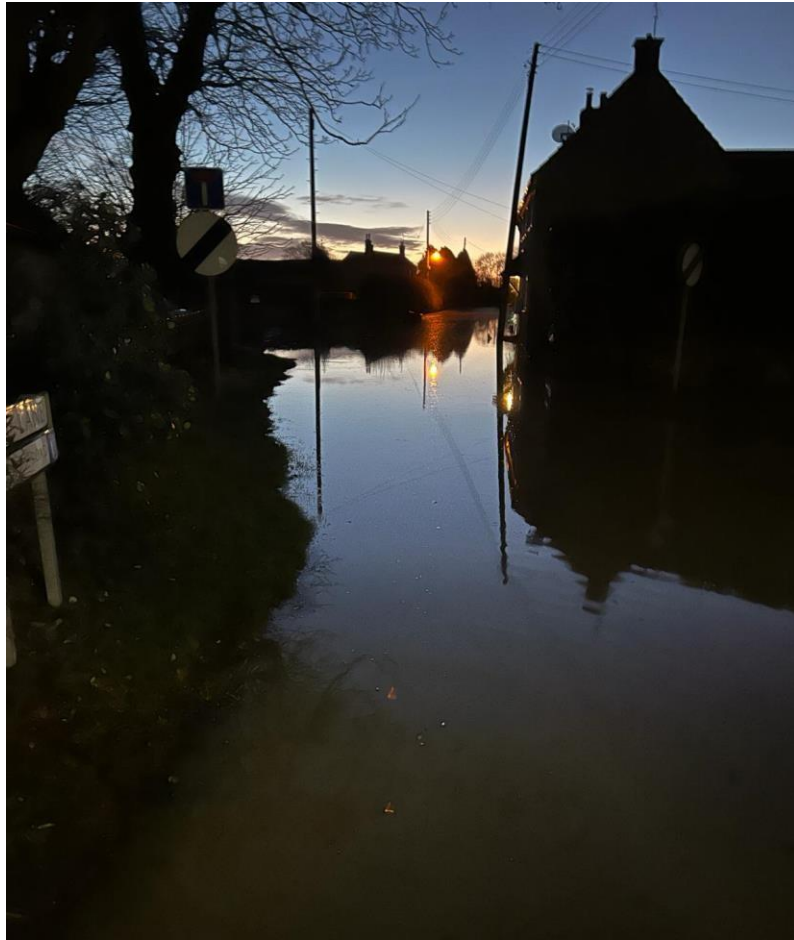
(Photo 3 - 07:20 04.01.2024 Mill Lane)

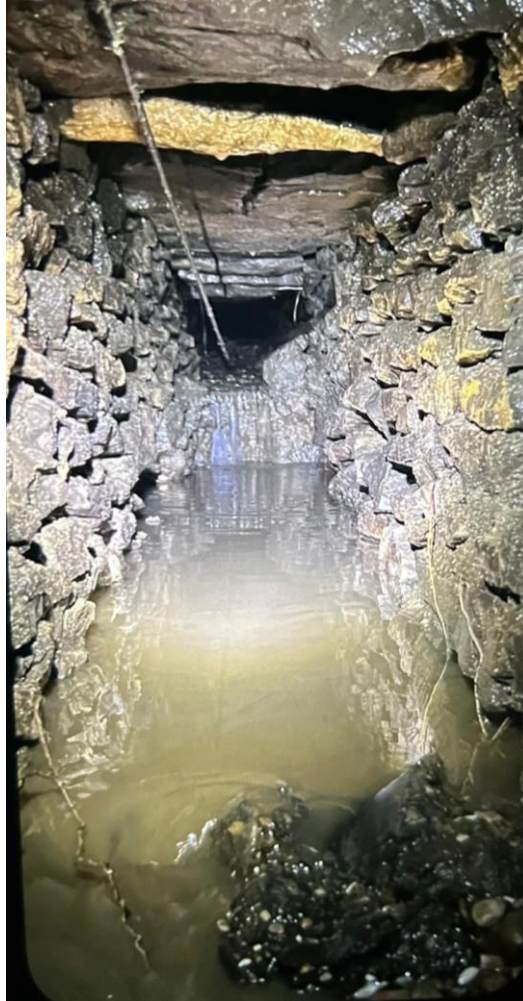
27/02/2024: Following a detailed appraisal by Anglian Water of their assets from Mill Lane towards the East coast mainline it was reported that there was at least one blockage somewhere between the chamber opposite the [REDACTED] to the Chamber across the crossing to just in front of the [REDACTED].

It was also reported that the stone topped surface water culvert from the [REDACTED] chamber to the open ditches to the east of the crossing were 80% blocked. AW spent 3 days/nights clearing this culvert with specialist tankers.

Photo 8 Tallington Surface Water Drain after cleansing

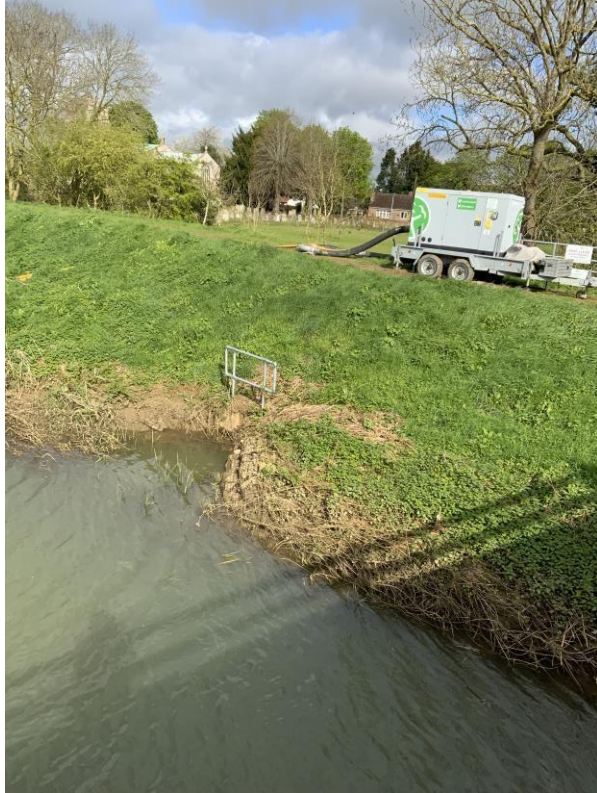
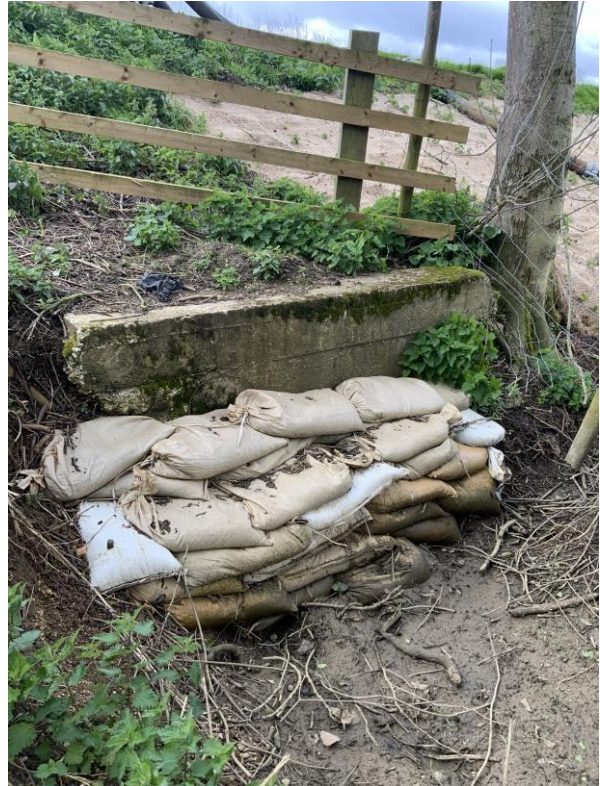
20/01/2024: The EA replaced the sandbags to block up the flap valve again due to the reported discovery of fish in the dyke parallel to the River Welland (509221E, 307797N), indicating a potential malfunction. Approximately, 45 sandbags were deployed to create a double skin barrier on the village side and this appears to have substantially reduced backflow from the river. It is reported that the Parish Council have agreed with the EA Ops Manager Field Teams that this is only a temporary measure, pending a review and appropriate improvements.

09/04/2024: During a site visit on 09/04/2024 an EA pump was situated on the bank of the river and the sandbags were still in-situ on the dyke side face of the flap valve. The flap valve was not visible as it was under the water level.

Photo 9 EA Trailer pump and flap valve asset adjacent to the bridge and sandbags deployed dyke side of flap valve

It is recommended that the ownership of the flap valve asset is confirmed by the EA and the asset owner then considers investigating the flap valve functionality and replace / improve the asset to ensure correct functionality is maintained.

Following a CCTV survey on the 14th of May 2024, it is understood that works to replace the existing flap valve with a more heavy duty variety are currently being considered by the EA.
