## Section 19

Flood and Water Management  
Act 2010

Ref S19-870 – Tallington

Date and version number –  
15/07/2025

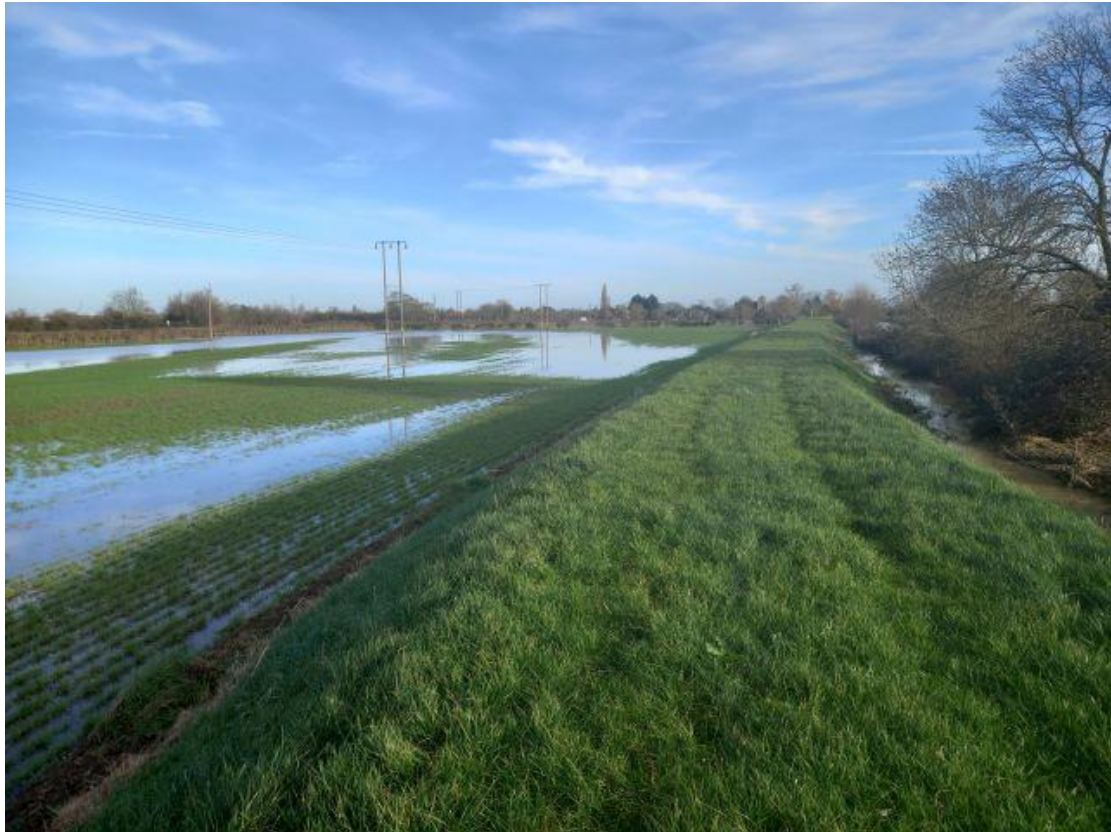
*Photo 2 – Flooding of agricultural land to the west of Tallington dated the 04<sup>th</sup> of January 2024 at approximately 12:30. Source: resident*

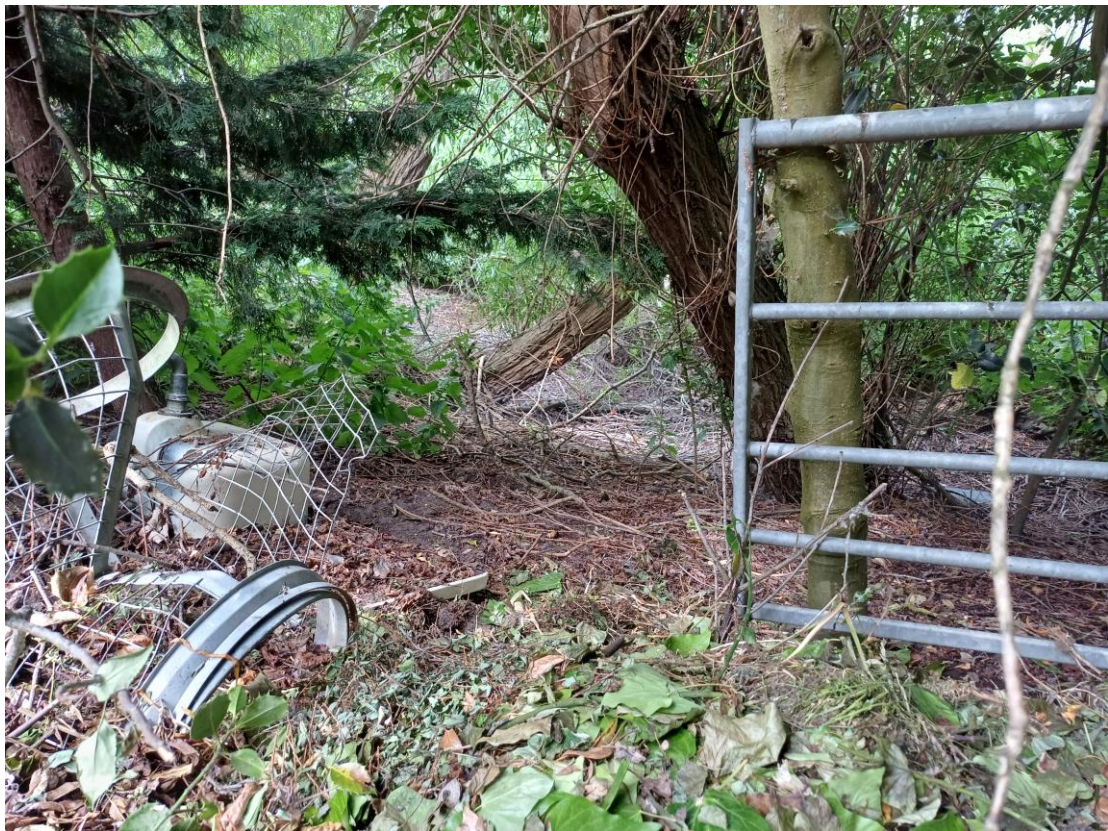
*Photo 3 – Remnant of the former River Welland. Source: Lincolnshire County Council dated 20/06/2025*

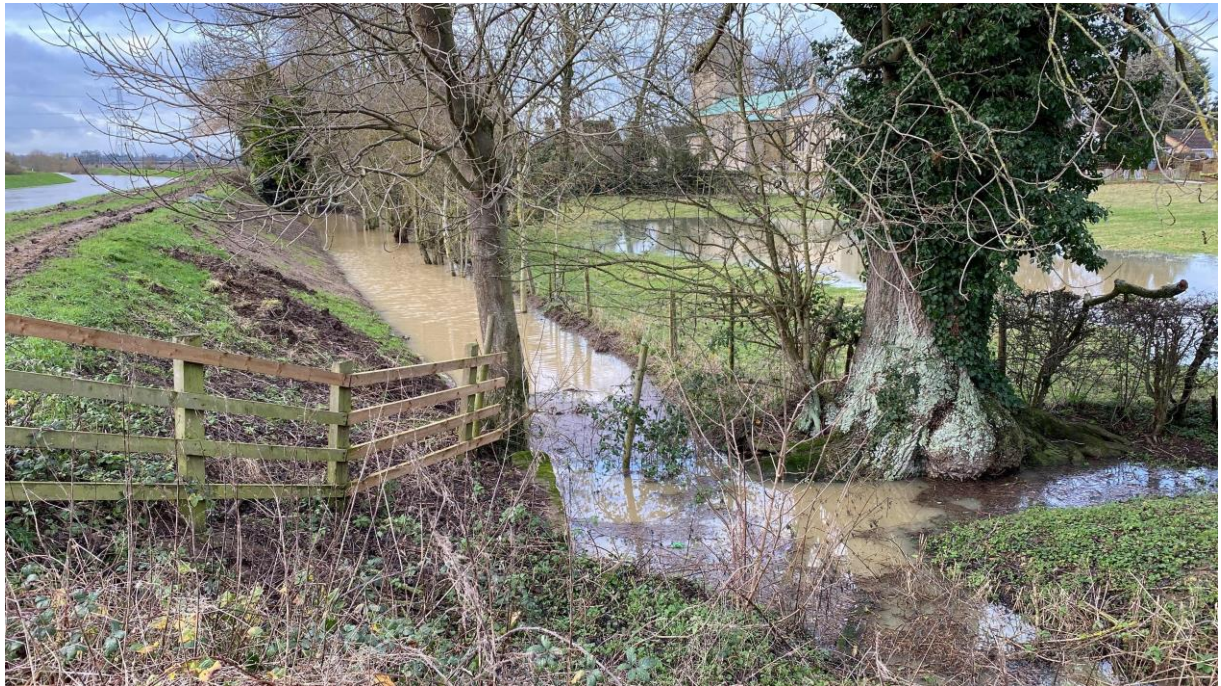
*Photo 4 03/01/2024 Just north of the River Bridge looking west*

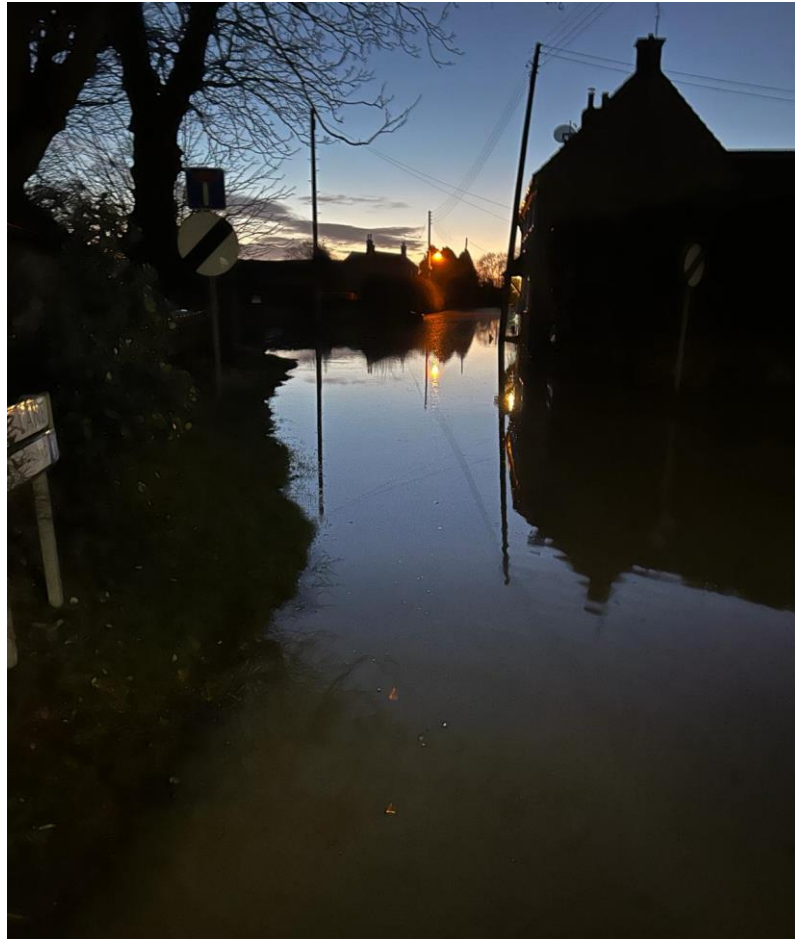
*Photo 5 07:20 04.01.2024 Mill Lane*

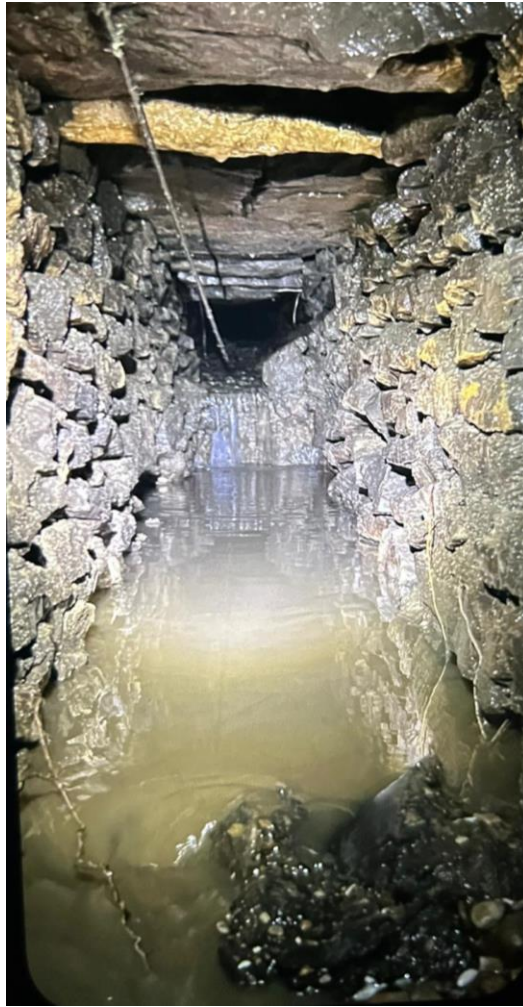
It was also reported that the stone topped surface water culvert from the [REDACTED] chamber to the open ditches to the east of the crossing were 80% blocked. AW spent 3 days/nights clearing this culvert with specialist tankers.

*Photo 10 Tallington Surface Water Drain after cleansing*

It is recommended that AW, LCC, and SKDC consider supporting a partnership funded project to repair / refurbish the surface water sewer that runs along Main Road to Searsons Close and / or to explore what other opportunities may exist to reduce the risk of surface water flooding in Tallington.

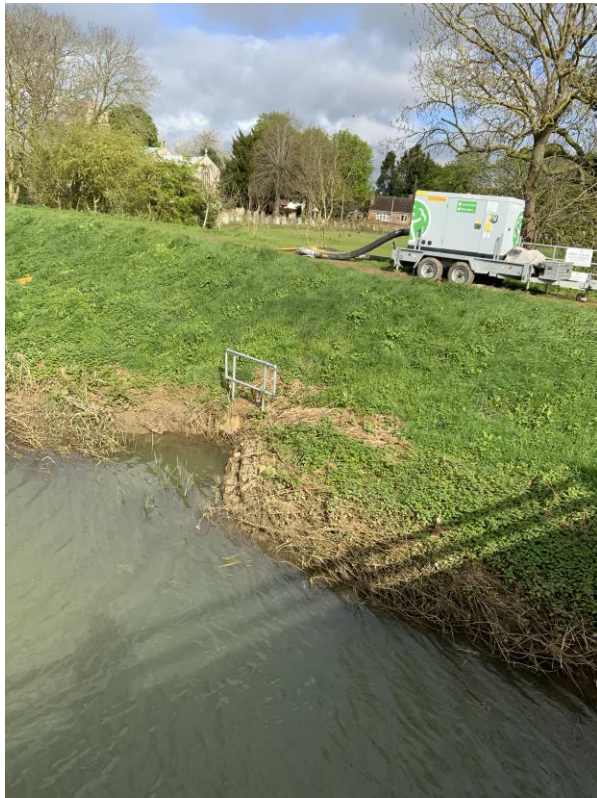
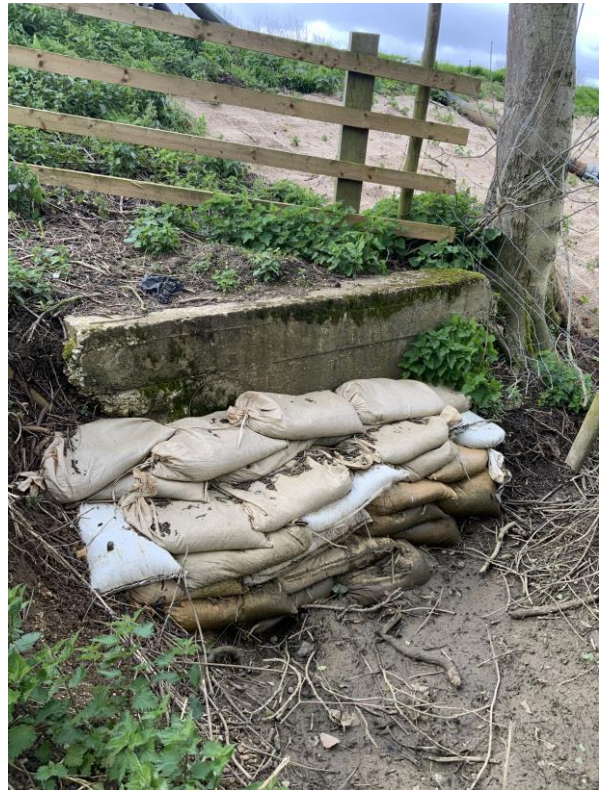
**20/02/2024:** The EA replaced the sandbags to block up the flap valve again due to the reported discovery of fish in the dyke parallel to the River Welland (509221E, 307797N), indicating a potential malfunction. Approximately, 45 sandbags were deployed to create a double skin barrier on the village side, and this appears to have substantially reduced backflow from the river. It is reported that the Parish Council have agreed with the EA Ops Manager Field Teams that this is only a temporary measure, pending a review and appropriate improvements.

**09/04/2024:** During a site visit on 09/04/2024 an EA pump was situated on the bank of the river and the sandbags were still in-situ on the dyke side face of the flap valve. The flap valve was not visible as it was under the water level.

*Photo 11 EA Trailer pump and flap valve asset adjacent to the bridge and sandbags deployed dyke side of flap valve*

It is recommended that consideration be given to confirming the ownership of the flap valve asset by the EA, with the asset owner then considering investigating and ensuring the functionality of it. Furthermore, consideration should be given by the asset owner to the installation of a trash screen on the inlet of the outfall to minimise the risk of future blockage

Following a CCTV survey on the 14<sup>th</sup> of May 2024, it is understood that works to replace the existing flap valve with a more heavy duty variety are currently being considered by the EA.
