## Section 19

Flood and Water Management  
Act 2010

Ref S19-870 – Tallington

Date and version number –  
15/07/2025

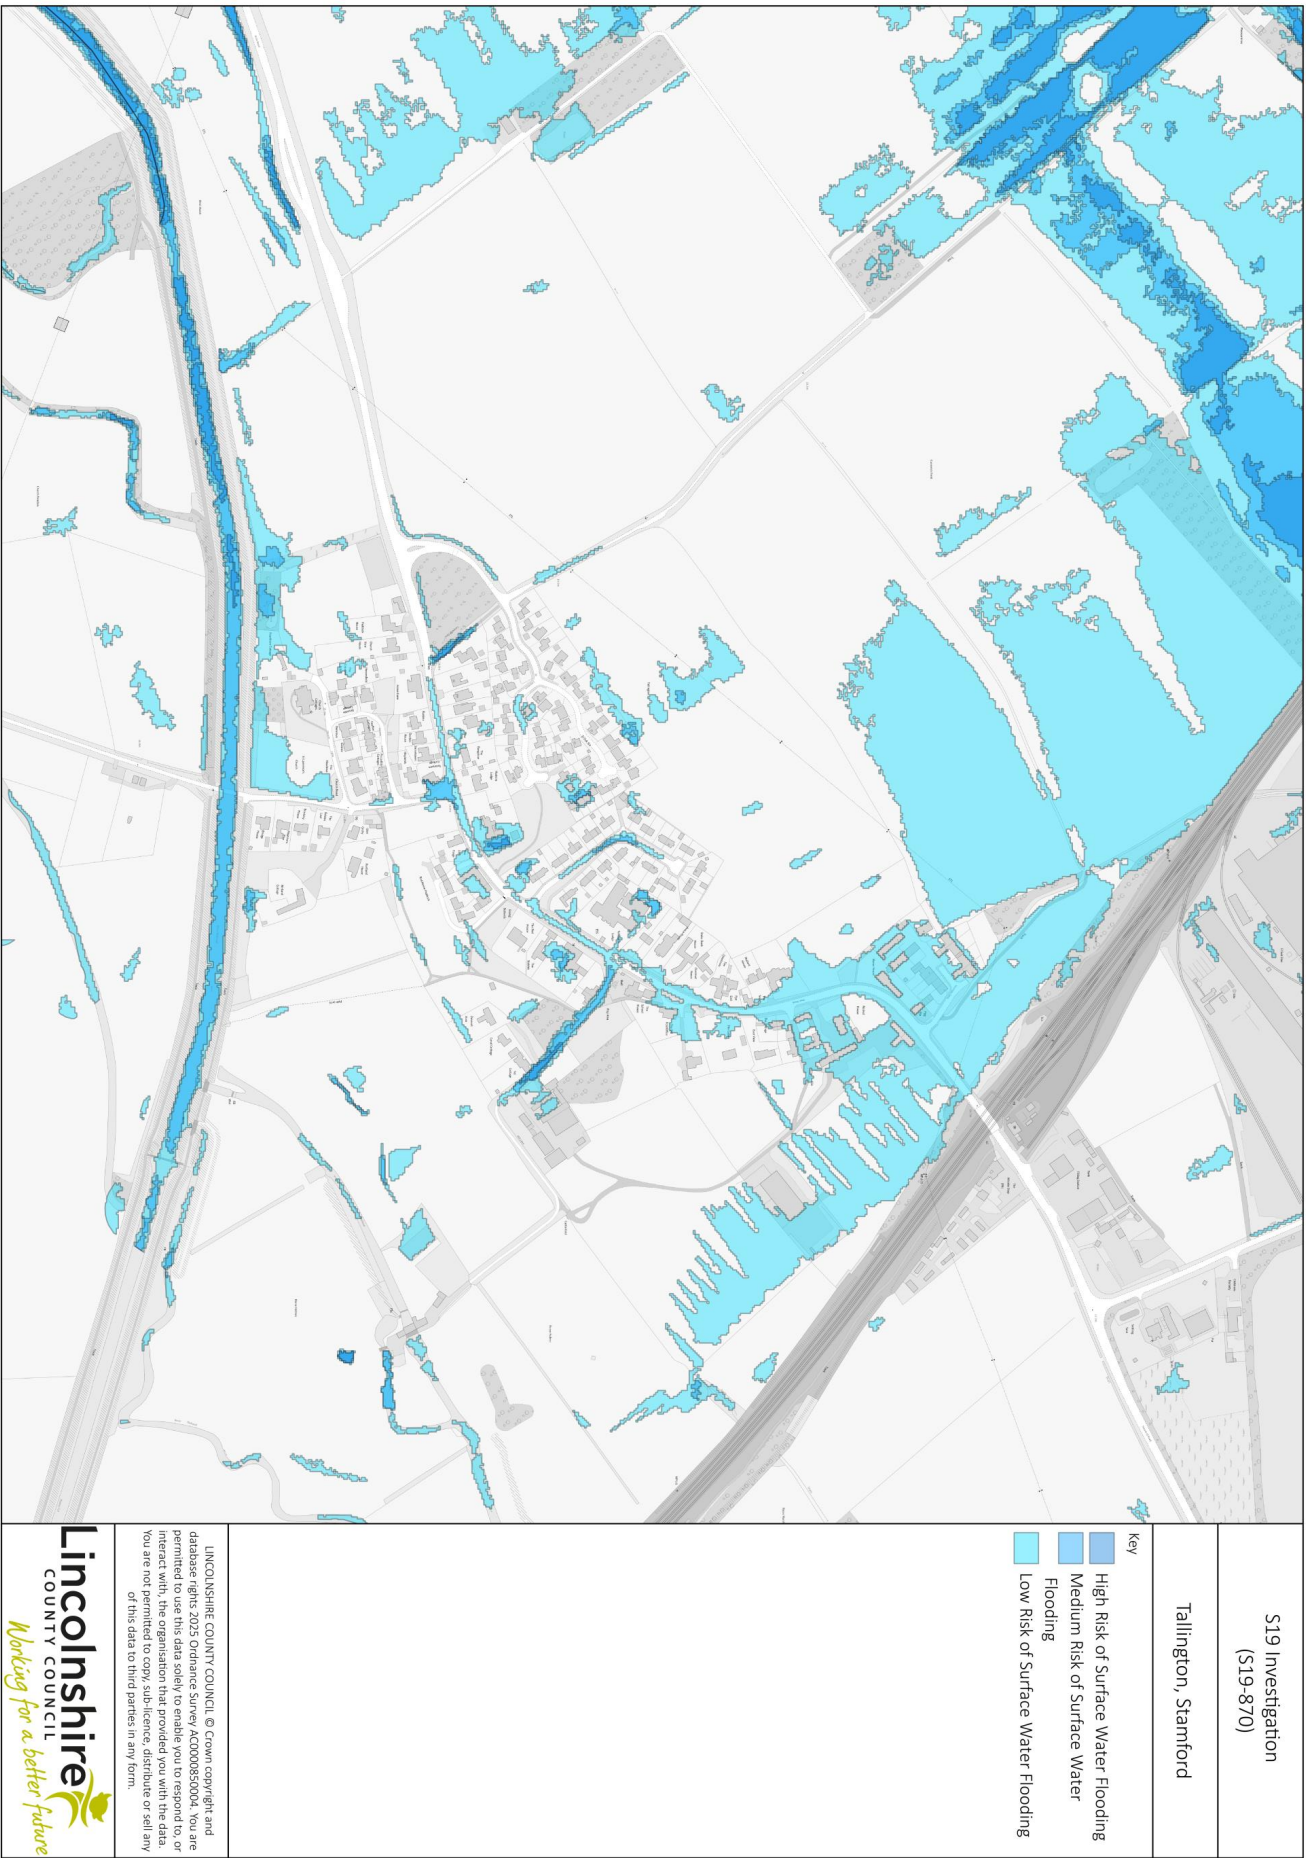
The Properties are situated in an area where the risk of surface water flooding is identified as being very low to medium (Figure 2).

Figure 2 – Risk of flooding from surface water for land in and around Tallington

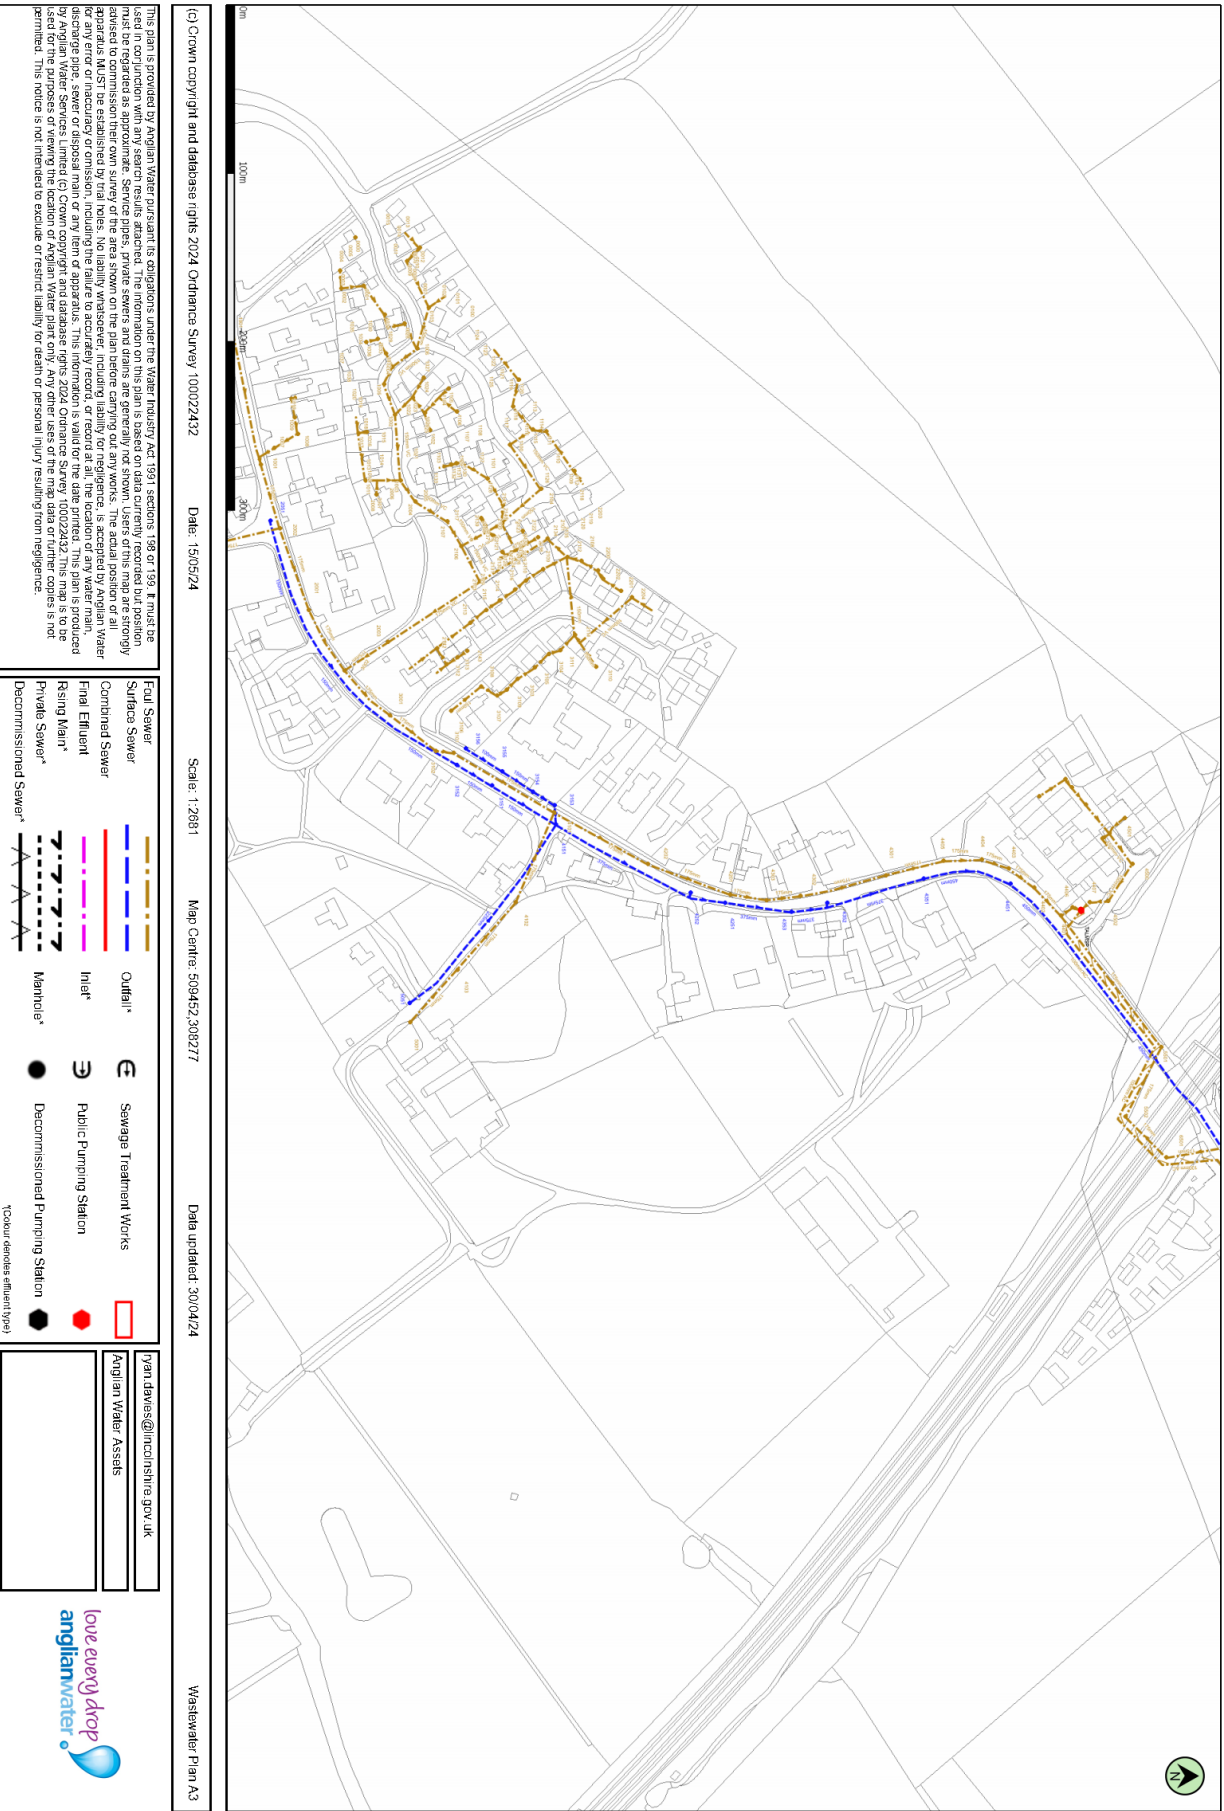
Based on available records, the drainage connectivity of the local area is outlined in Figures 3 and 4 below. Notwithstanding the current asset records shown in Figure 3, it is understood by LCC through correspondence with Anglian Water that they are looking to de-vest the surface water sewer (which flows under the East Coast mainline) as it does not serve any of their statutory duties under the Water Industry Act 1991.

Figure 3 – Anglian Water assets in the affected area

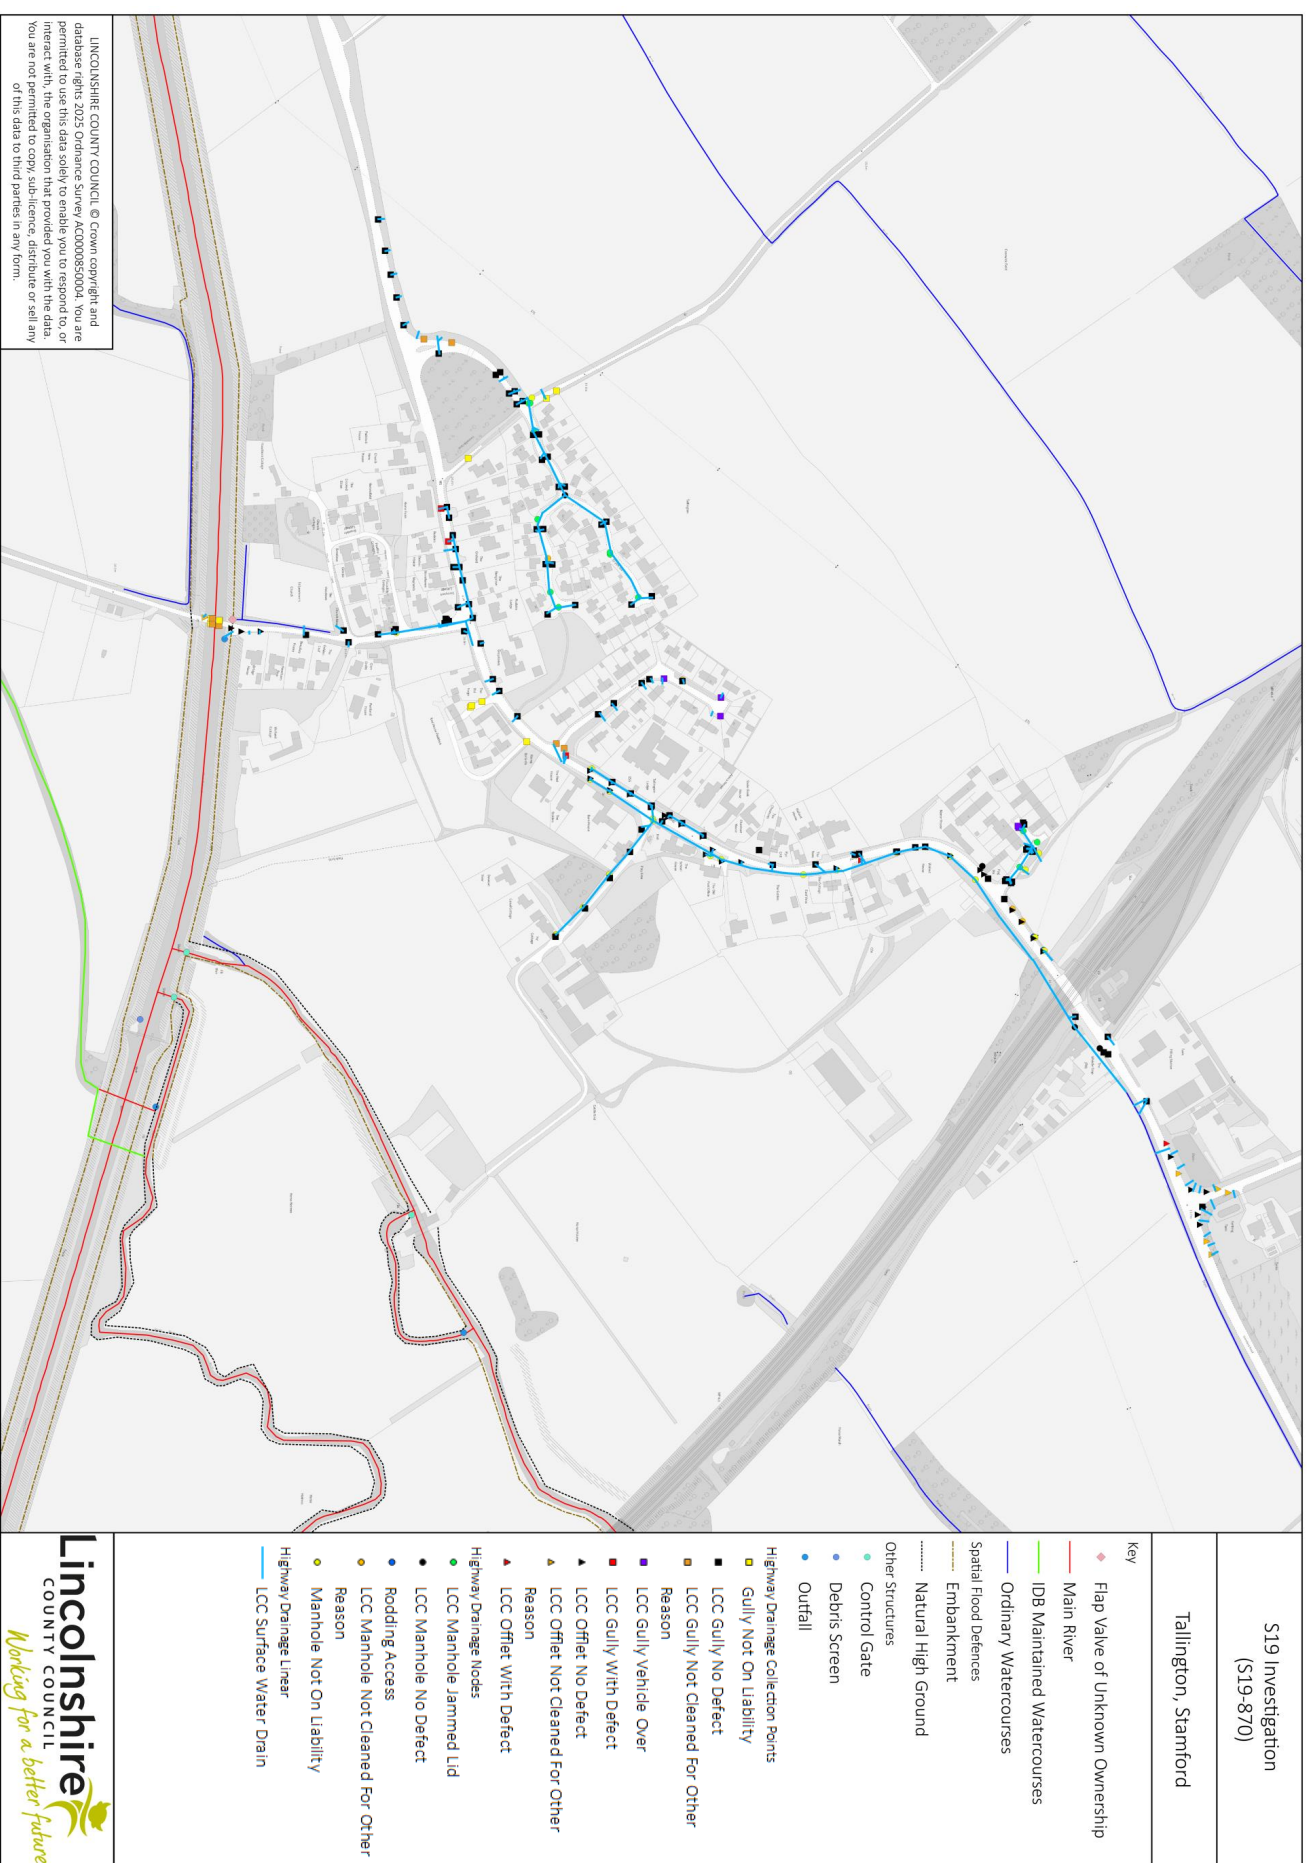
LCC does not have a continuous coverage of recorded highway drainage assets in this area, with some highway gullies connected to local surface water sewers and AW sewers. The highway gullies at the junction of Tallington Road and Main Road connect to a highway drain, and a highway drain is noted along the junction with Mill Lane and Main Road, which extends north east along the Main Road and under the railway lines.

Figure 4 – Drainage connectivity in the affected area

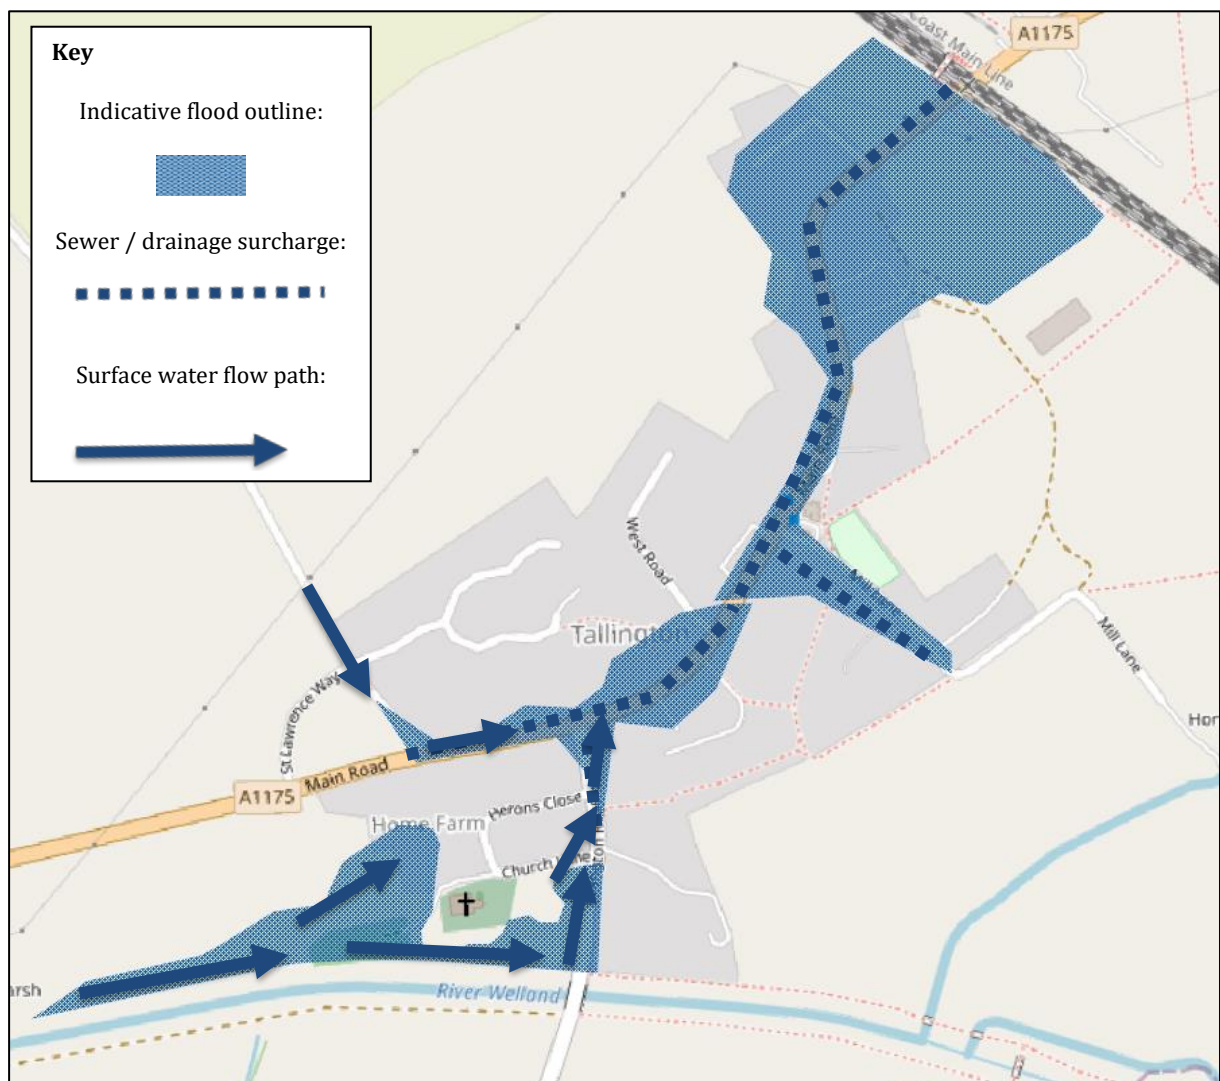
*Figure 7 Indicative flood event outline as reported by residents*

Information provided by residents to the Parish Council suggests that a total of 24 properties were internally flooded throughout the village on Tallington Road, Church Lane, Main Road, Mill Lane and Searson Close. Most properties impacted were located directly adjacent to a highway / surface water sewer.
